Procedure for lubricating standard underbody hoist.

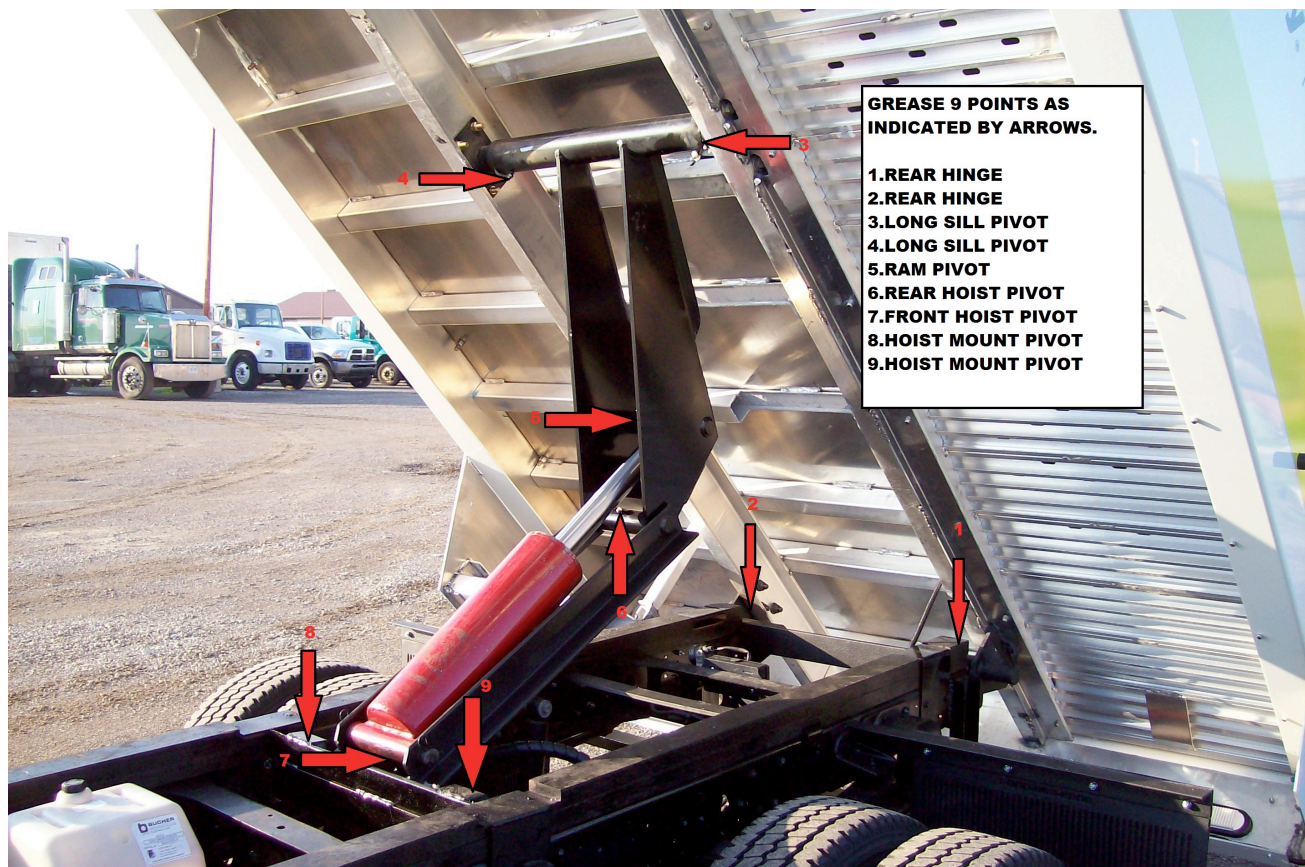
Please refer to the attached picture layout documenting where the critical grease nipples are located. There are 9 of them in total, 7 on the hoist and 2 on the rear hinge assembly.

It is critical that joints 5 and 6 (ram pivot and rear hoist pivot) accept grease and that grease flows out ends of tubing. Ceasing of these connections will cause a situation whereas the dump body will get 'stuck' in the UP position and will not lower without assistance.
